US Army Corps  
of Engineers®  
Engineer Research and  
Development Center

## **Periodic Inspections of Hilo, Kahului, Laupahoehoe, and Nawiliwili Breakwaters, Hawaii**

Armor Unit Monitoring for Period 2001-2005

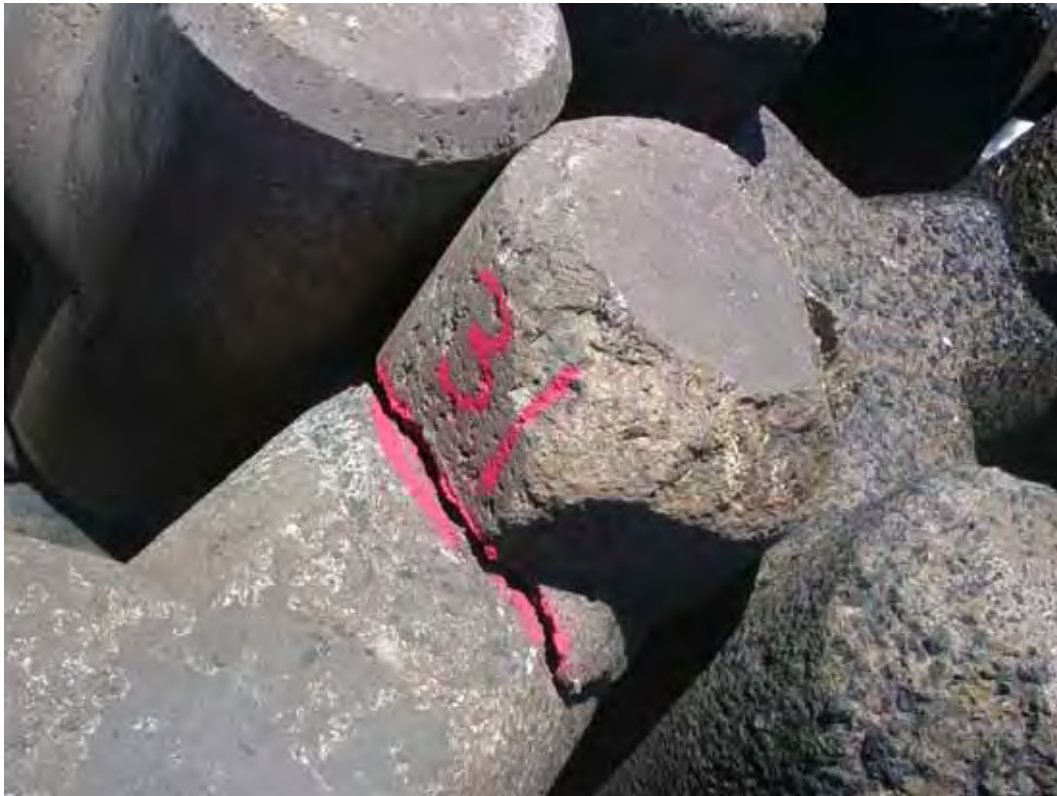
Figure D47. Damage location 64, sta 16+14, ocean side, rib #70, tribar with broken can.

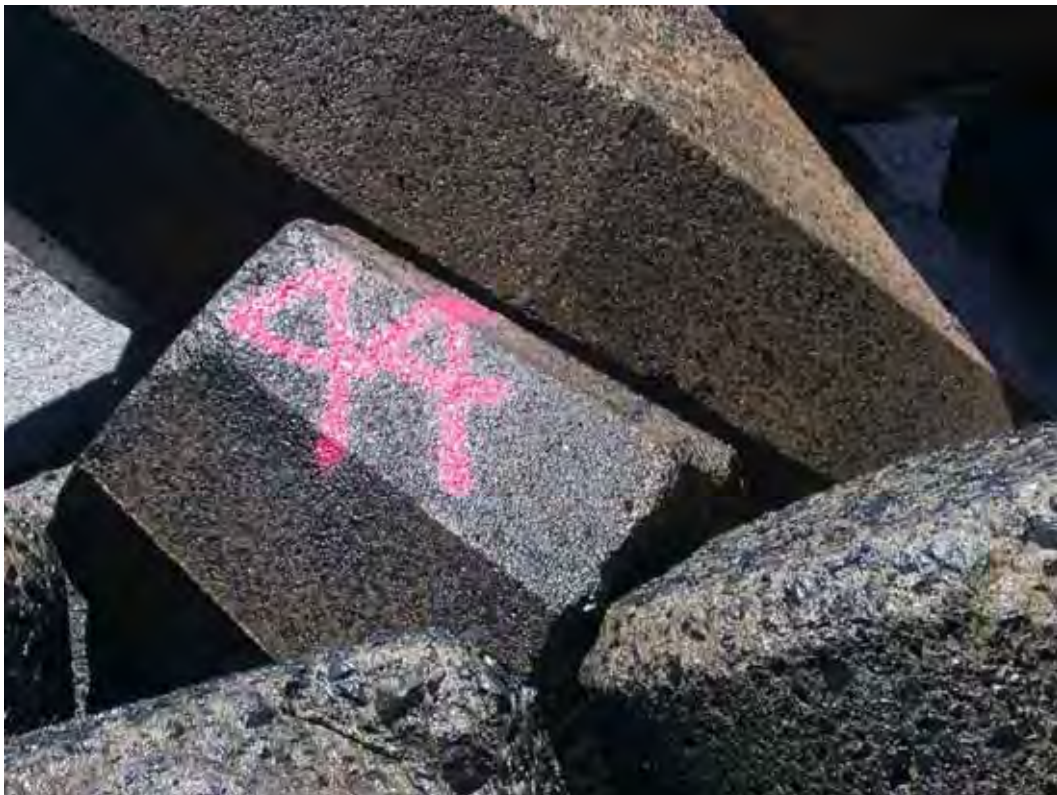
Figure D58. Damage location 76, sta 18+24, ocean side, rib #105, dolosse with fluke tip break.

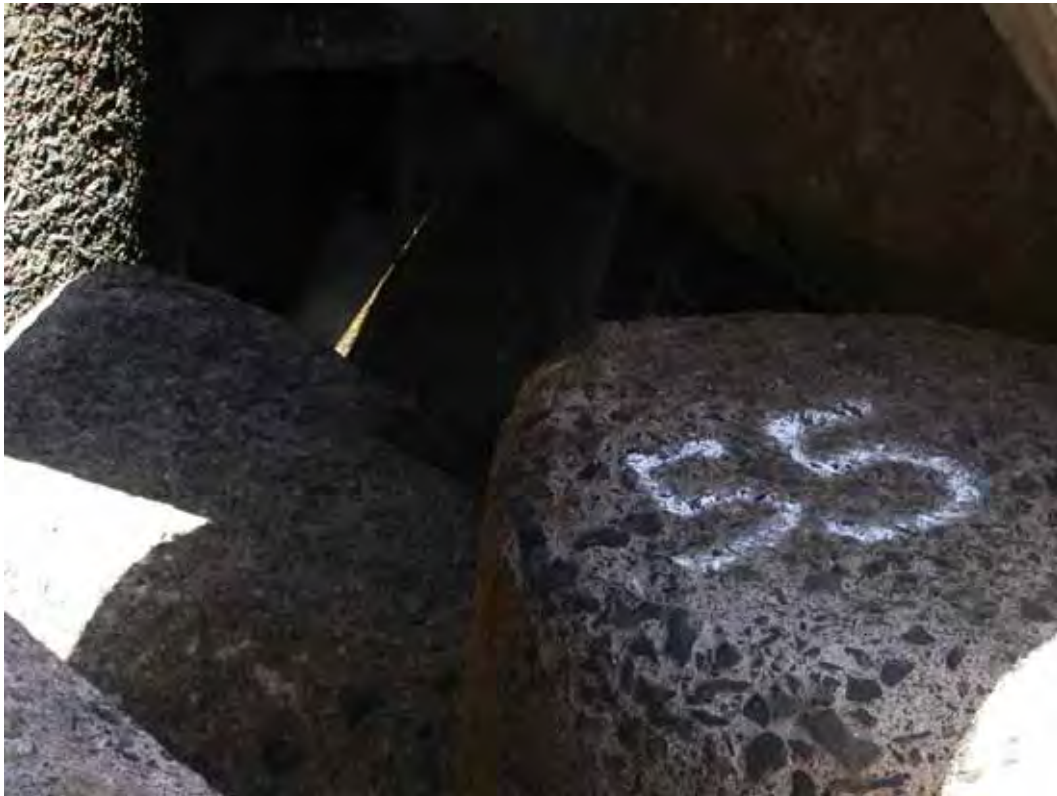
Figure D66. Damage location 88, sta 19+48, ocean side, rib #124, tribar with broken leg.

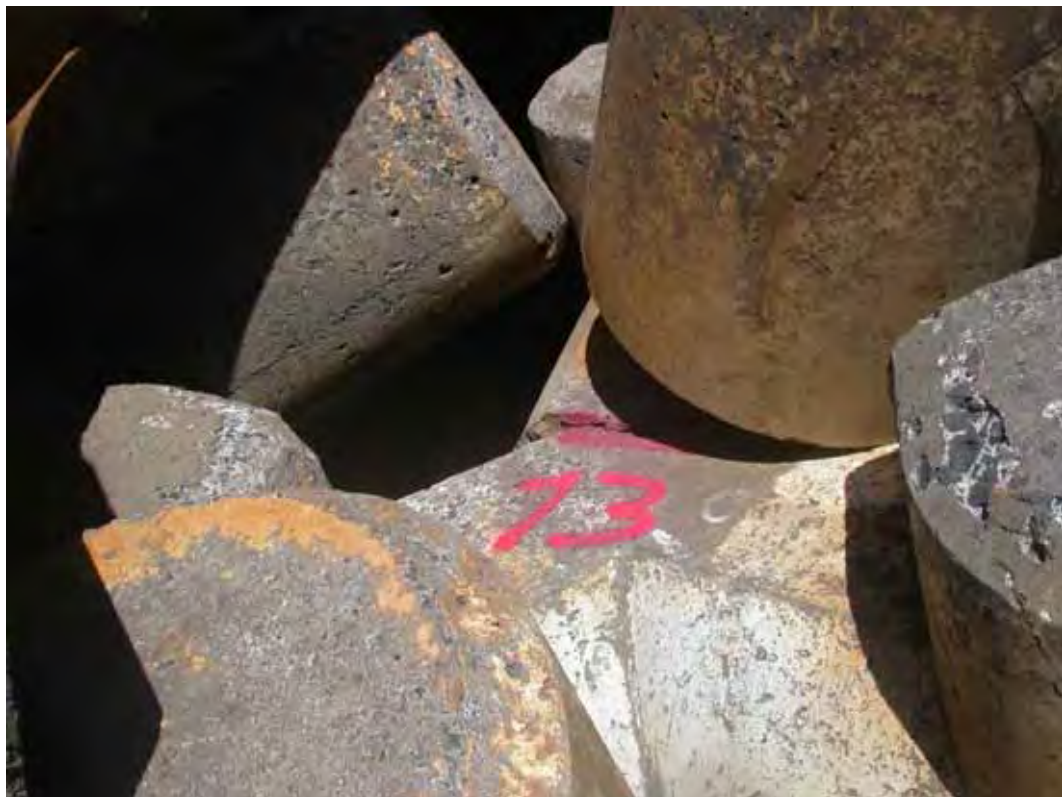
Figure D75. Damage location 106, sta 20+26, ocean side, rib #137, tribar with broken leg.

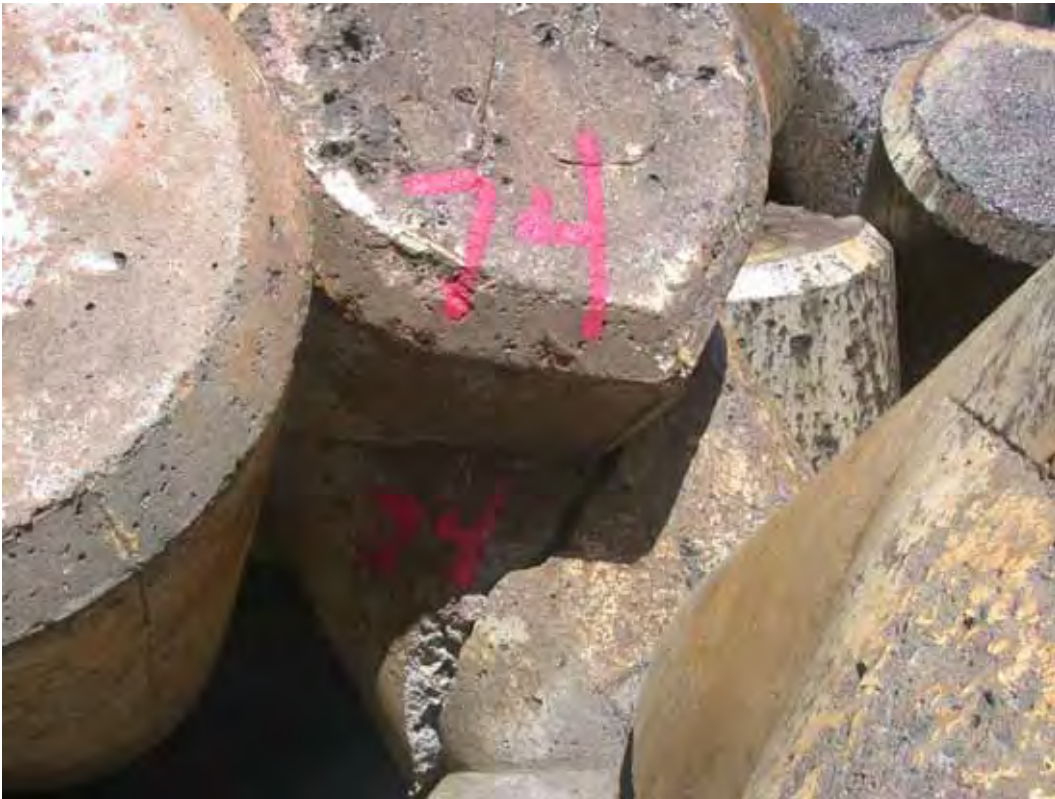
Figure D76. Damage location 107, sta 20+32, ocean side, rib #138, tribar with broken leg.
